Some background informations about the FT-897 mods

Mods - Summary View

Mods - Detail View

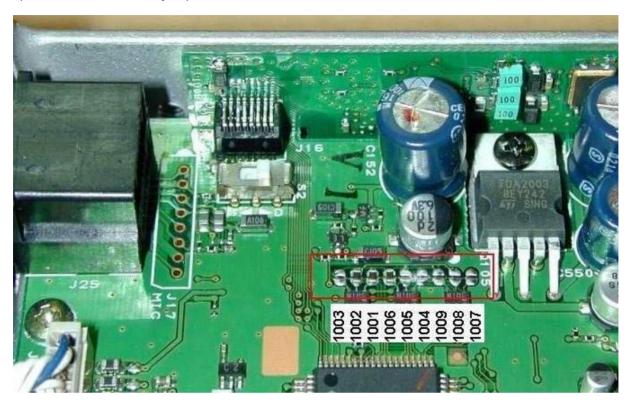
DG2IAQ	MARS/	German
Jumper	original = "B3"	CAP	version = " B1 "
J1007		X	X
J1008	X	X	X
J1009		X	
J1004			
J1005			
J1006	X	X	X
J1001	X		X
J1002			X
J1003			X

Don' forget to do a MASTER RESET after that !!

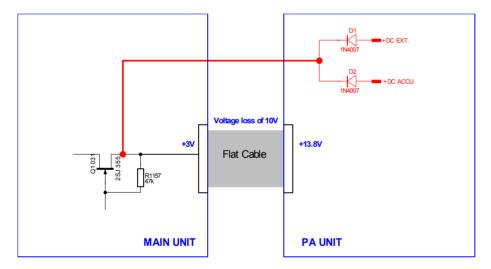
As I didn't want to reassemble the PA UNIT too, I decided to use 2 additional diodes to get the DC voltage from the (1) EXT and (2) ACCU connections on the upper side of the PA UNIT.

So soldered a separate cable which is parallel to the +13VUS line and removes this voltage loss. No problems any more !!

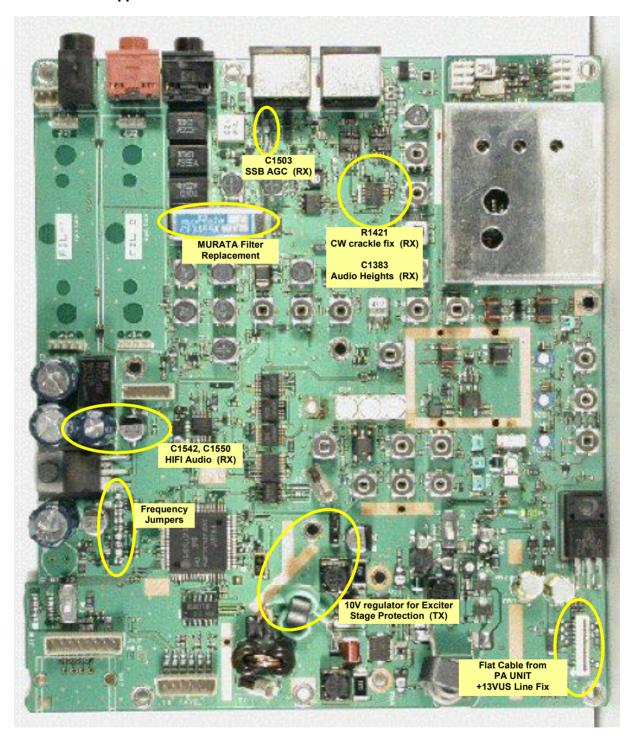
MAIN UNIT - Upper Side

For my mods you only have to disassemble and remove the MAIN UNIT. All other PCB can be left at their place.

Remove all screws from the MAIN UNIT PCB. All cables can be connected and don't have to be removed too.

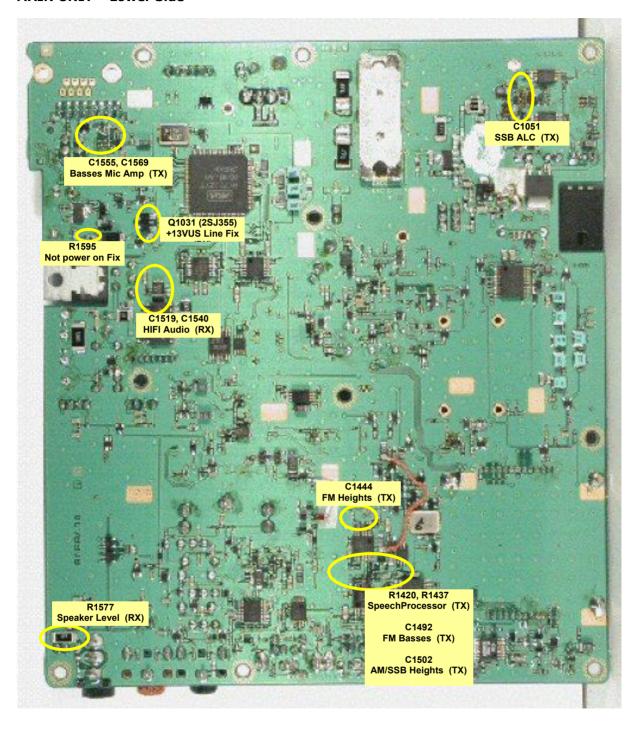
MAIN UNIT - Lower Side

For the down side of the PCB you can remove the PCB from case and turn it toward to you. Please take care not to damage the flat cable on the right side!

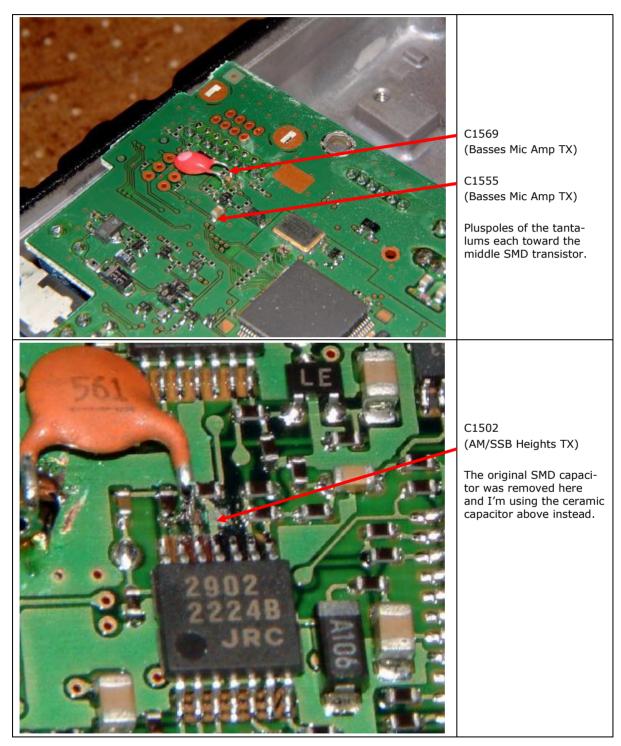
Remove R1437 (SpeechProcessor TX)

I removed R1437 to get a much higher output level. Now you would hear a difference between speechprocessor ON/OFF and the audio distortions are reduced significant cause you don't need as high menu levels on no. 074 than before. But now we would only have a switchable additional audio amplifier and nothing more. Does this make sense !? No ! So I had to limit the audio level to get a real speechprocessor.

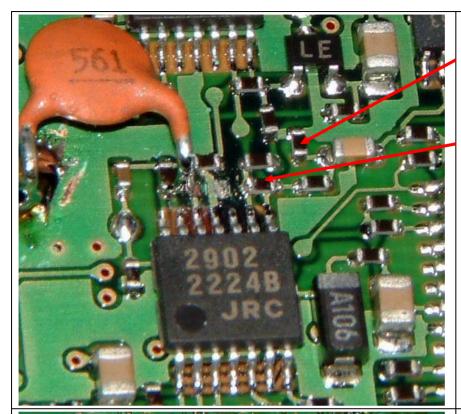
R1420 (SpeechProcessor TX)

The Clipper diodes and the lowpass capacitor are soldered on the connections of R1420

And I did this with two antiparallel lownoise diodes. As clipping on the audio side always produces some distortions and a "high pitched" sound characteristics (like loosing all basses) I added a capacitor to have an audio lowpass filter too.

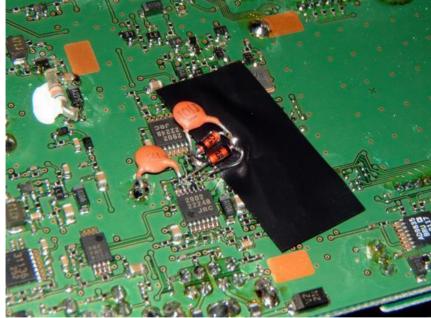
So the final SpeechProcessor looks like this. The 100pF were replaced by 150pF after taking that picture.

I'm using a pair of BAT85 schottky diodes as they only have a forward voltage of 0,3V. So the clipping starts on the quieter voice parts too. But it should be possible to use 1N5711, HP2800-2810 or other lownoise diodes with 0,7V too.

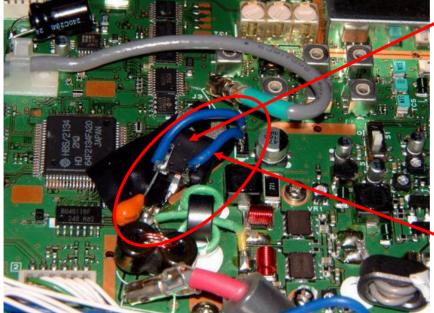
10V fixed regulator for Exciter Stage Protection

You can solder that in a "flying way". I soldered the middle PIN (ground) to the PCB ground which gives enough mechanical stability. By removing the BIAS jumper you have the needed both connections for +13.8V DC and the power supply line toward the Exciter Stage.

The 1.85A self-resetting fuse was placed instead of this cable later.

The solution is simple here too. Just add a 10V fixed voltage regulator into the +DC line.

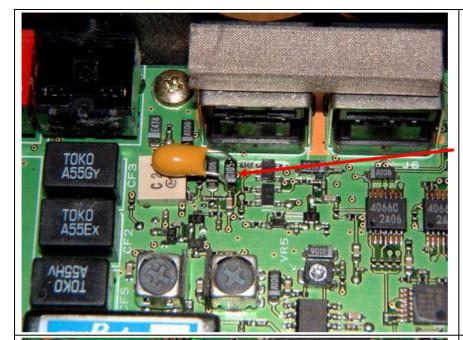
C1503 (AGC time constant RX)

12.	C1503 (1µF)	10μF parallel	Raise delay time constant of "AGC SLOW" for much better SSB audio on strong stations
13.	C1383 (1.5nF)	1nF	More heights on AF audio lowpass
14.	R1421 (82k or 100k)	470k parallel	Eliminating audio overload of audio IC and eliminate CW crackling noise too YAESU TroubleShooting Note TSN-0405 / 02. June 2004
15.	C1519 (0.1µF)	2.2µF parallel	HIFI Basses Audio Amp
16.	C1540 (1µF)	10μF parallel	HIFI Basses Audio Amp
17.	C1542 (47µF)	470μF / 16V	HIFI Basses Audio Amp
18.	C1550 (470µF)	1000μF / 16V	HIFI Basses Audio Amp
19.	R1577 (3.9)	bridged	Higher audio level on internal 8 ohms speaker

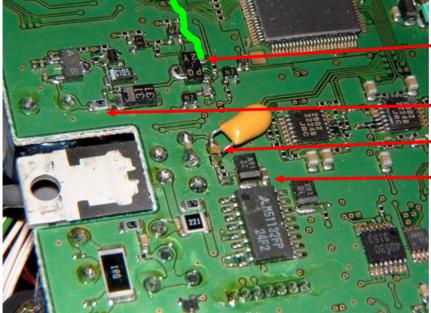
Q1031 Upper pin for 13VUS bridging cable (shown green)

R1595 (power on fault)

C1540 (HIFI audio RX)

C1519 (HIFI audio RX)

This fault is documented by YAESU. There's a small 6.8 ohms SMD resistor on the input of a 78L05 fixed voltage regulator. This resistor can fail and a break of the 13.8V DC input line would occur. Simply replace that 6.8 ohms resistor. I would recommend to use a real 1/8W resistor which should be more rough and which can handle higher temperatures under strong consumption. Never easily bridge that resistor!! I found out that there will be an ON-flash cause of the fast charging of some bigger electrolytes. These voltage peaks can destroy a FET!! This low resistant resistor is needed to have a little power-on delay and a smoother charging of those electrolytes.

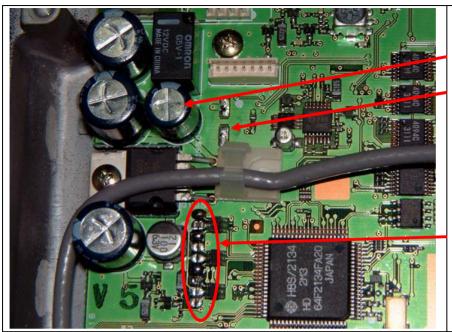
C1550 (HIFI audio)

C1542 (HIFI audio) The cap is desoldered on this picture.

Jumpers for MARS/CAP
